Case Study Report

Auglaize County Courthouse Renovation

Perfection installed a \$1.2 million design-build HVAC and controls system which was part of the \$8.6 million complete restoration of the County Courthouse.

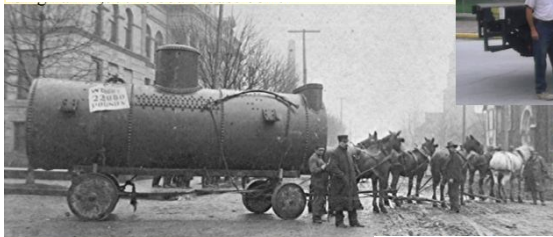
Original 22,000 lb. courthouse boiler

The existing system was a century old coal fired steam boiler with split unit air conditioning scattered randomly throughout the building. The air conditioning system in one of the courtrooms was so loud that it needed to be turned off when the room was in use.

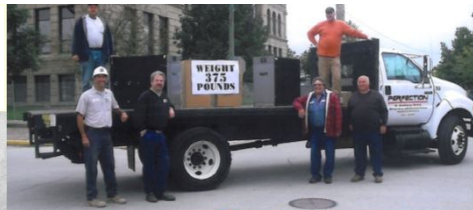
New 375 lb. courthouse boiler

Perfection installed a state of the art water source heat pump system with high-efficiency boilers, cooling tower and direct digital controls. The new system has dedicated fresh air systems with heat recovery wheels to maintain proper air quality. The building is 49,200 square feet and Perfection expects the BTUs per square foot to be 40% less than with the old system.

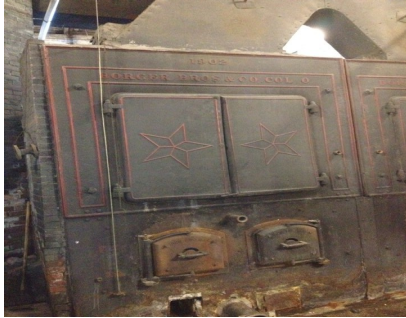
Existing Coal Boiler from 1902

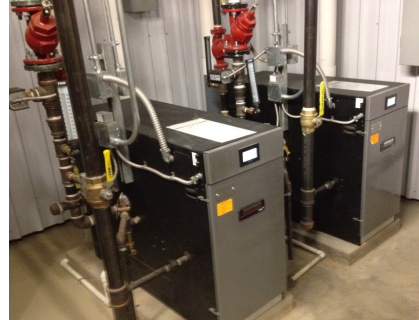
New High-Efficiency Boilers 2012
